This program will address the most common system problems associated with the A&E Patio Awnings supplied by The Dometic Corporation. Our intent is to provide you with a guideline of checks to make, should you encounter one of the following symptoms.

SECTION 1 HARDWARE COMPONENTS

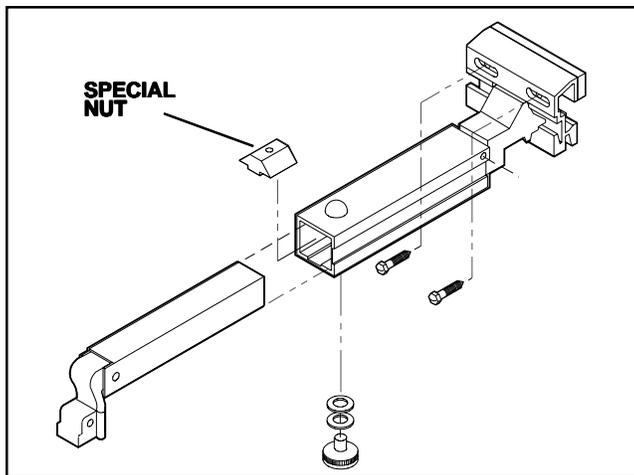
1.1 NUTSERT OR SPECIAL NUT

The **nutsert** is simply a threaded fastening device used to tighten down the black adjustment knob. If the knob will not tighten, first remove the secondary rafter assembly from the hardware. Turn the knob to determine if the nutsert is stripped or spinning. If so, replace the nutsert. If you cannot turn the knob it will be necessary to replace both the nutsert and the black adjustment knob.

On some arm assemblies the nutsert has been replaced with a **SPECIAL NUT**. If the knob will not tighten, first separate the rafter assembly. Turn the knob to determine if the special nut is stripped. If so, replace the special nut. If you cannot turn the knob, it will be necessary to replace both the special nut and the back adjustment knob.

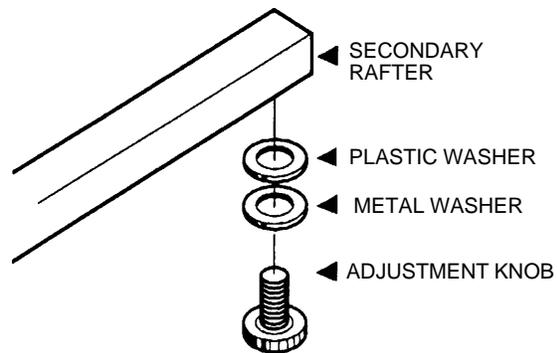
1.2 WASHER STACK-UP

Washer stack-up merely means the proper positioning of the washers on the stud of the black adjustment knob. Remove the knob and check for proper washer position. The plastic washer should be against the main rafter, and backed by the metal washer for stiffness. If the stack-up is not proper it should be corrected.

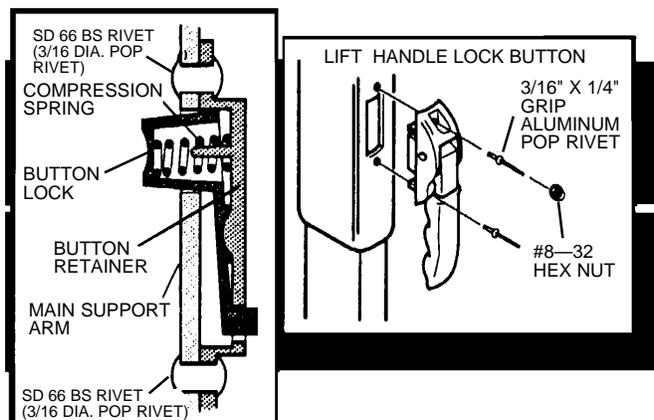
1.3 PUSH BUTTON ASSEMBLY

The push button assembly locks the main support arm to the adjustable arm assembly and controls the height of the awning in the open position. To check it, open the awning to full extension. Look inside the main support arm, and activate the push button to see if the locking pin is moving in and out of the hole in the adjustable arm assembly. If the locking pin does not move, or has been

broken off, the push button assembly must be replaced. At times the lock pin of the push button assembly can break off and jam between the push button housing and the adjustable arm assembly, making it difficult to extend the main support arm.

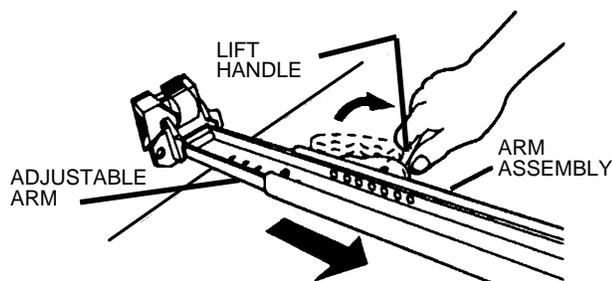
1.4 ADJUSTABLE ARM ASSEMBLY

The adjustable arm assembly allows for telescoping height adjustment of the main support arm, and it connects to the bottom mounting bracket to support the weight of the awning. If the main support arm cannot be extended freely, the adjustable arm assembly should be checked. Remove the adjustable arm assembly and check for nicks, burrs, bends or twists. If any deflection is noted, the adjustable arm assembly must be replaced. For ease of operation apply GO-EASY, a special lubricant.

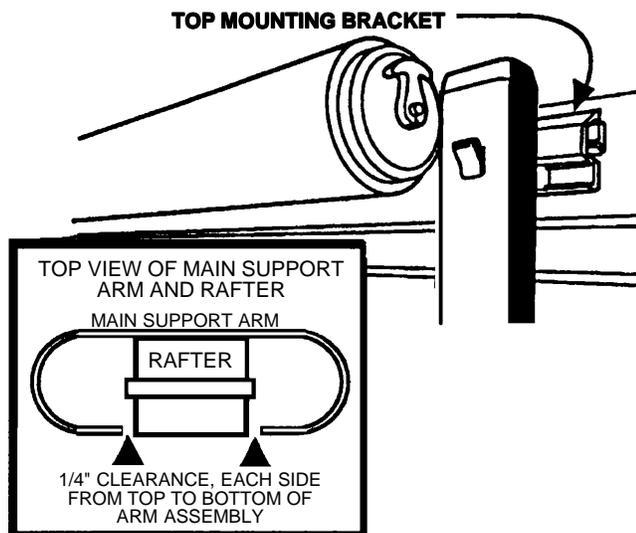
1.5 TOP MOUNTING BRACKETS

The top mounting bracket supports the main rafter assembly to hold the awning in the open extended position, and allows the rafter to pivot into the "C" channel of the main support arm. Each top mounting bracket should be mounted directly over the awning rail so the screws go through the "C" portion of the rail.

On the Series 9000 awning the top mounting bracket can be mounted lower when possible. If the top mounting bracket is mounted above center of the awning rail, the aluminum guard may not cover the fabric completely in the closed position. If this is the case, relocate the top mounting bracket accordingly.

The top mounting brackets have slotted holes for the mounting screws, allowing them to be adjusted side to side. To adjust the brackets, close the awning and sight down the main support arm and the main rafter. The clearance on each side of the rafter should be approximately 1/4 inch. If clearance is not appropriate, adjust the top mounting bracket(s) as necessary.

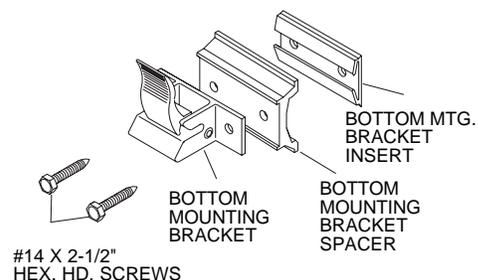
1.6 BOTTOM MOUNTING BRACKETS

The bottom mounting brackets are screwed to the floor line of the unit, and they support the weight of the awning. They also provide a quick release to set up the awning in the patio position.

If a bottom mounting bracket settles, sags, or becomes loose it can reduce the clearance between the top casting of the torsion and the extension of the top mounting bracket, making operation difficult.

Check the bottom mounting bracket for looseness or settling, and tighten or reposition it accordingly for proper operation.

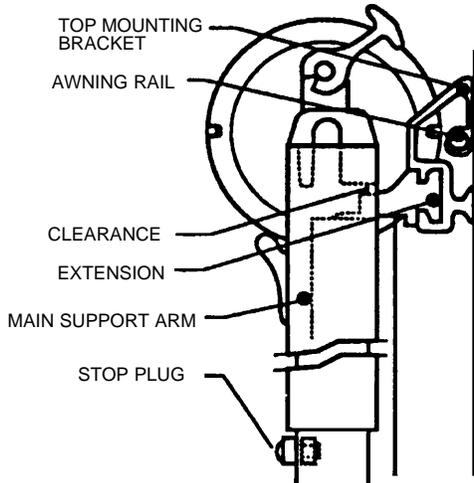
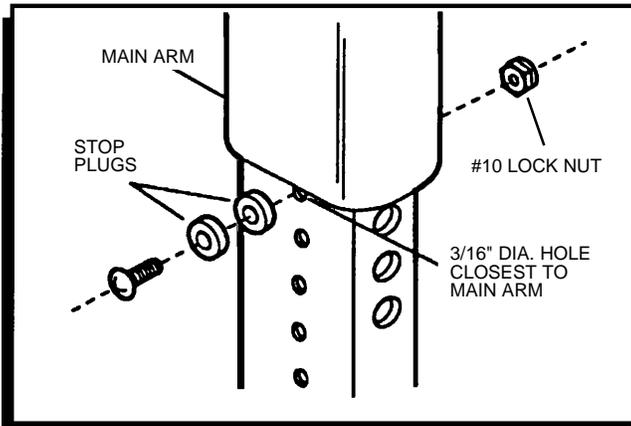
1.7 STOP PLUG

The stop plug is a mechanical stop that supports the main arm when opening and closing the awning. It controls the clearance between the top casting of the torsion to the extension of the top mounting bracket. This clearance should be 1/4 inch to 1 inch. To adjust the clearance, raise or lower the stop plug as needed. On the 9000 and 9500 Series awning the clearance should be kept to a minimum for best operation.

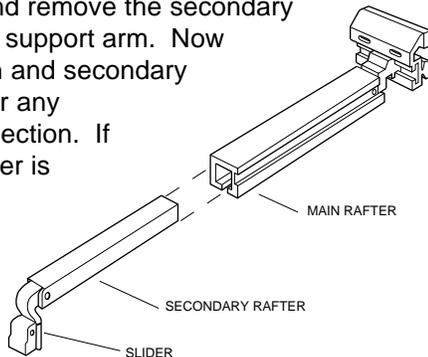
1.8 RAFTERS

The rafters telescope from the top mounting brackets to the main support arms to provide tension on the fabric in the full open position. If the rafters are bent or twisted, this will hinder the operation of the awning. Open the awning and remove the secondary rafter from the main support arm. Now sight down the main and secondary rafters and check for any bends, twists or deflection. If one or the other rafter is not true it should be replaced.

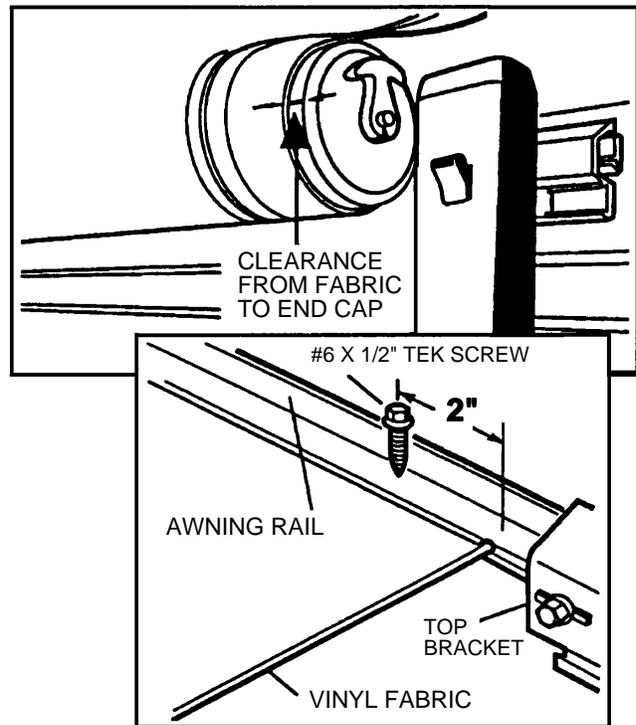
2.1 POSITION

For the awning to operate properly the fabric must be positioned properly in the awning rail and on the roller tube. Open the awning and check the position of the fabric between the top mounting brackets. If the fabric is not centered, remove the tek screws, center it, and replace the screws.

When the fabric is properly positioned, next check the position of the fabric on the roller tube. The clearance from the end cap of the torsion assembly to the edge of the fabric must be the same on each end. If it is not, adjust the fabric on the tube as necessary. On the Elite 9000 and 9500 awning the fabric is held in place to the weatherguard with 1/8" pop rivets. Check the position of the fabric at each end of the weatherguard. If the fabric has shifted, remove the pop rivets, center the fabric and re-rivet.

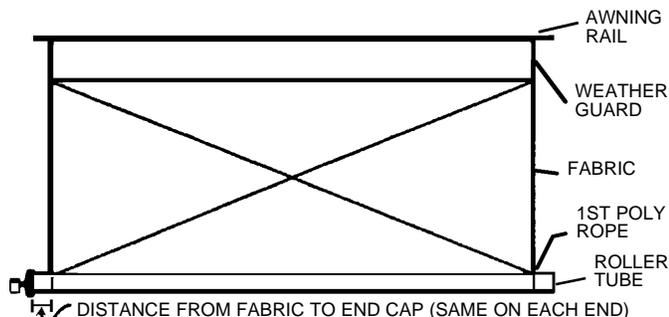
2.2 SQUARE

If the fabric on the awning is out of square, it could cause the fabric to telescope in one direction when rolling up, or to not hang properly in the open position.

To check fabric for square, measure from the top right hand corner of the fabric (not the weatherguard) to the bottom left hand corner at the poly rope. Now measure from the top left hand corner to the bottom right hand corner as shown below.

In this check, the difference of the two dimensions should be no more than one inch. If it is more, the fabric is out of square, and replacement would be necessary.

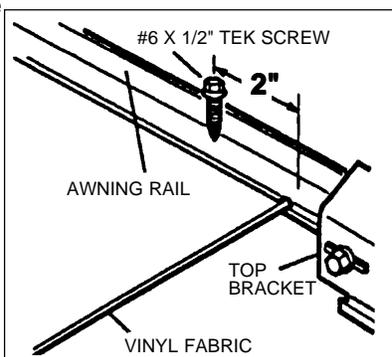
2.3 WEATHERGUARD

The weatherguard is the last 15 inches of the awning that encloses the fabric in the rolled up position. It protects the striped fabric from the environment and elements. The weatherguard is a heavy 17 oz. vinyl fabric.

When the vinyl weatherguard or fabric has excessive wrinkles, it will be necessary to stretch the weatherguard or fabric. Open the awning and allow the fabric to warm up. Remove one Tek screw, grasp the weatherguard, stretch it, and resecure the screw. Repeat this procedure for the other end, making sure to stretch each side an equal distance, keeping the fabric centered between the top mounting brackets. Close and reopen the awning three times. If wrinkles are still present, repeat the above stretching procedure. This may have to be done 4 or 5 times before all wrinkles disappear.

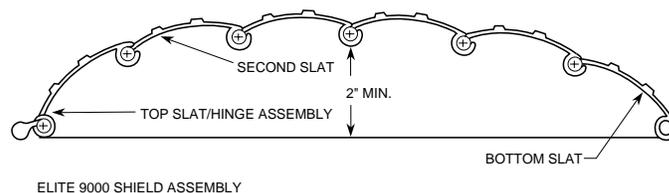
2.5 ALUMINUM GUARD

When the awning is fully extended, the aluminum guard should have an arch of at least 2 inches. The arch helps water to run off rather than between the sections of the guard.

To check the aluminum guard for proper arch, open the awning to full extension, making sure the fabric is taut. Hold a flat edge to the bottom of the guard and measure from the flat edge to the inside of the arch at its highest point. If the measurement is less than 2 inches, the guard should be replaced.

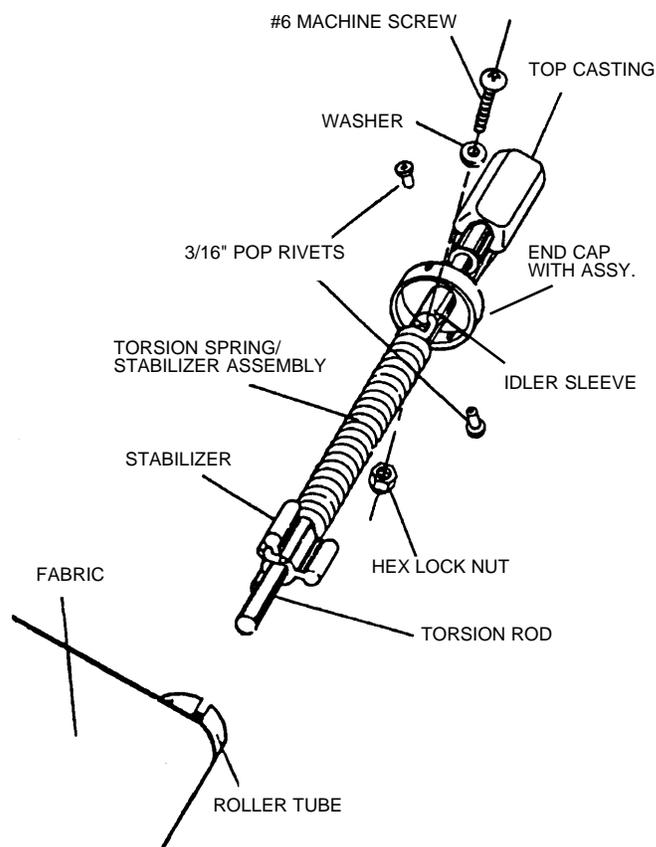
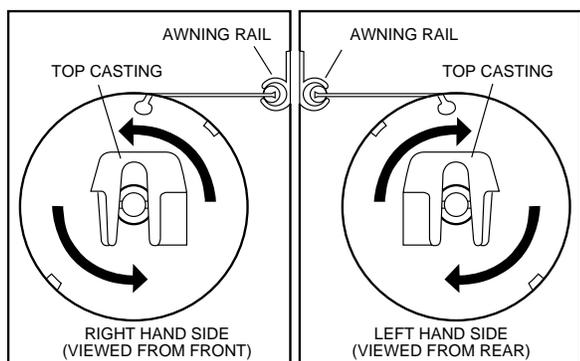
2.8 TORSION

When difficulties are experienced in rolling the awning up, the tension on the torsion should be checked. In

most cases adding a few turns of torque to each end will correct the problem. If all tension has been lost, refer to the following chart and apply the specified number of turns as indicated. This must be done with the awning extended two feet away from the coach.

When winding the torsion, be sure to wind in the proper direction.

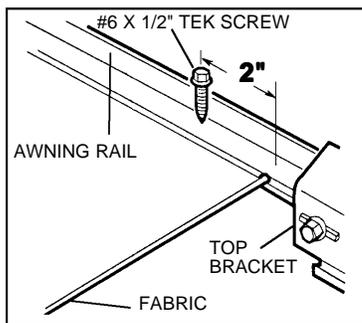
2.12 TEK SCREWS

The Tek screws are the two screws installed through the awning rail of the coach. They keep the aluminum guard from shifting in the awning rail. On vinyl and some acrylic awnings (see Sec. 2.5) they keep the fabric from shrinking with age. If one Tek screw is missing, the fabric will pull toward the remaining Tek screw causing the fabric to wrinkle.

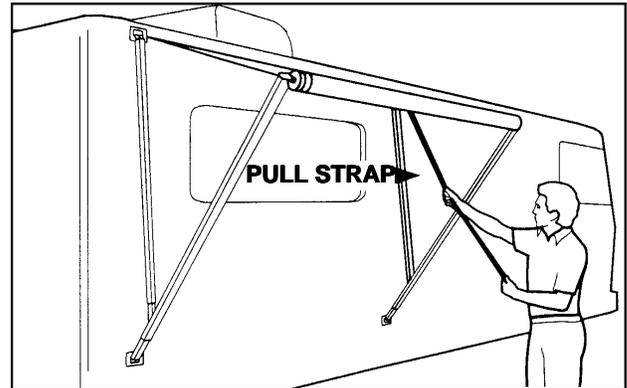
3.2 CLOSING

On the 9000 and 9500 Series, when rolling up the awning, the roller tube assembly should not be slowed down before reaching the aluminum guard. This could cause the roller tube to stall at the guard.

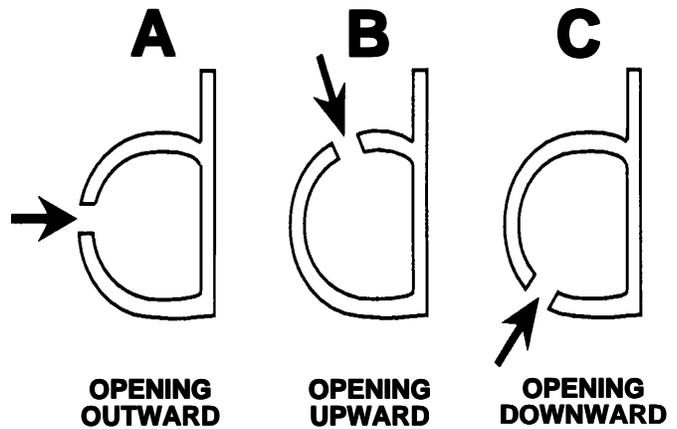
4.3 TYPE

There are three types of awning rail used in the RV industry. Of these, type A and B (see below) are acceptable for use on the 9000 Series awning that utilizes a hinge slat (see Sec.2.5) . Type C should never be used on the 9000 Series that utilizes a hinge slat (see Sec. 2.5) as it could cause a binding problem on the aluminum guard assembly, but it is acceptable on the vinyl awnings.
