This program will address the most common system problems associated with the A&E Patio Awnings supplied by The Dometic Corporation. Our intent is to provide you with a guideline of checks to make, should you encounter one of the following symptoms.

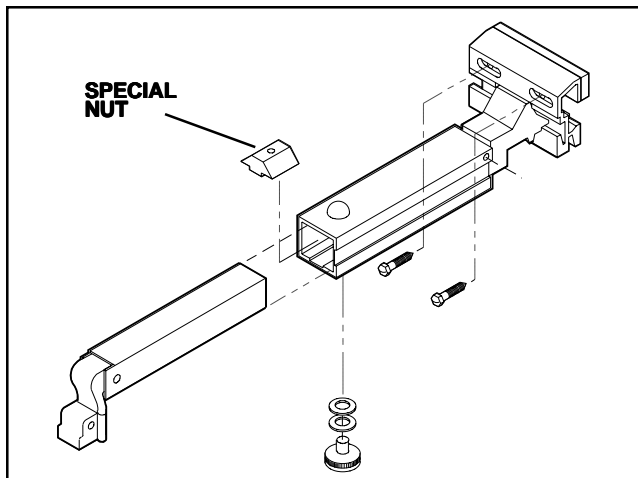
1.1 NUTSERT OR SPECIAL NUT

The **nutsert** is simply a threaded fastening device used to tighten down the black adjustment knob. If the knob will not tighten, first remove the secondary rafter assembly from the hardware. Turn the knob to determine if the nutsert is stripped or spinning. If so, replace the nutsert. If you cannot turn the knob it will be necessary to replace both the nutsert and the black adjustment knob.

On some arm assemblies the nutsert has been replaced with a **SPECIAL NUT**. If the knob will not tighten, first separate the rafter assembly. Turn the knob to determine if the special nut is stripped. If so, replace the special nut. If you cannot turn the knob, it will be necessary to replace both the special nut and the back adjustment knob.

NOTE: The special nut could be a large hex nut as well as the one shown.

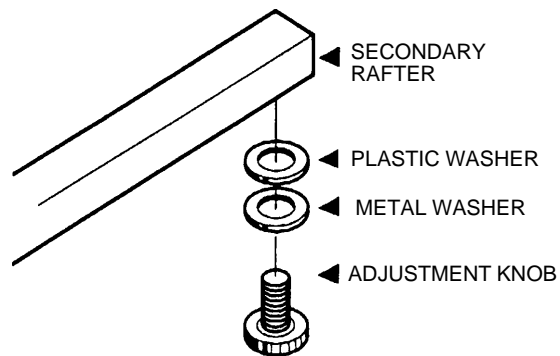
1.2 WASHER STACK-UP

Washer stack-up merely means the proper positioning of the washers on the stud of the black adjustment knob. Remove the knob and check for proper washer position. The plastic washer should be against the main rafter, and backed by the metal washer for stiffness. If the stack-up is not proper it should be corrected.

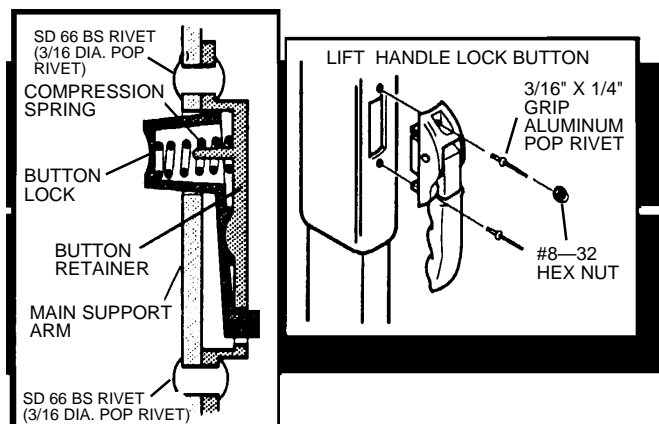
1.3 PUSH BUTTON ASSEMBLY

The push button assembly locks the main support arm to the adjustable arm assembly and controls the height of the awning in the open position. To check it, open the awning to full extension. Look inside the main support arm, and activate the push button to see if the locking pin is moving in and out of the hole in the adjustable arm assembly. If the locking pin does not move, or has been

broken off, the push button assembly must be replaced. At times the lock pin of the push button assembly can break off and jam between the push button housing and the adjustable arm assembly, making it difficult to extend the main support arm.

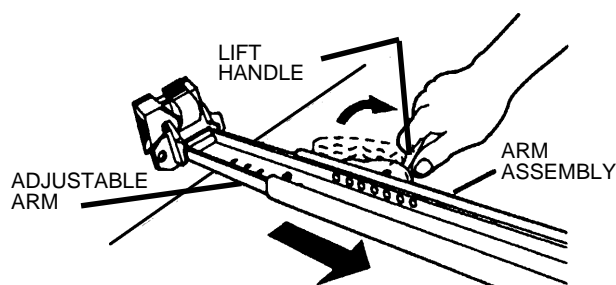
1.4 ADJUSTABLE ARM ASSEMBLY

The adjustable arm assembly allows for telescoping height adjustment of the main support arm, and it connects to the bottom mounting bracket to support the weight of the awning. If the main support arm cannot be extended freely, the adjustable arm assembly should be checked. Remove the adjustable arm assembly and check for nicks, burrs, bends or twists. If any deflection is noted, the adjustable arm assembly must be replaced. For ease of operation apply GO-EASY, a special lubricant.

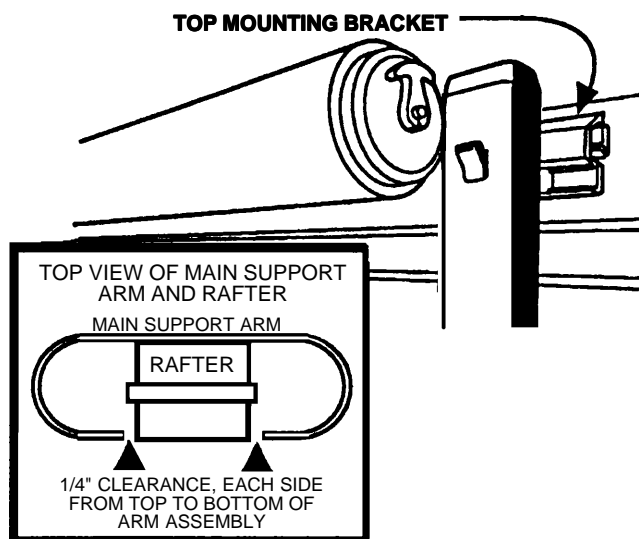
1.5 TOP MOUNTING BRACKETS

The top mounting bracket supports the main rafter assembly to hold the awning in the open extended position, and allows the rafter to pivot into the "C" channel of the main support arm. Each top mounting bracket should be mounted directly over the awning rail so the screws go through the "C" portion of the rail.

On the Series 9000 awning the top mounting bracket can be mounted lower when possible. If the top mounting bracket is mounted above center of the awning rail, the aluminum guard may not cover the fabric completely in the closed position. If this is the case, relocate the top mounting bracket accordingly.

The top mounting brackets have slotted holes for the mounting screws, allowing them to be adjusted side to side. To adjust the brackets, close the awning and sight down the main support arm and the main rafter. The clearance on each side of the rafter should be approximately 1/4 inch. If clearance is not appropriate, adjust the top mounting bracket(s) as necessary.

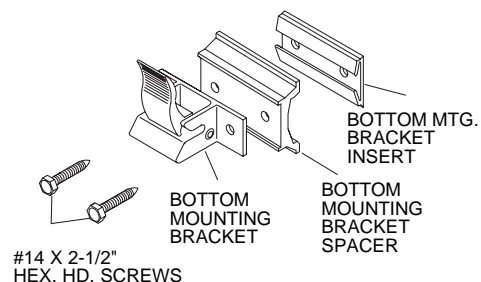
1.6 BOTTOM MOUNTING BRACKETS

If a bottom mounting bracket settles, sags, or becomes loose it can reduce the clearance between the top casting of the torsion and the extension of the top mounting bracket, making operation difficult.

Check the bottom mounting bracket for looseness or settling, and tighten or reposition it accordingly for proper operation.

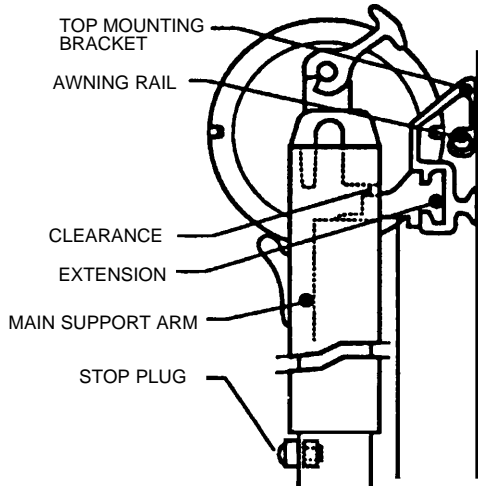
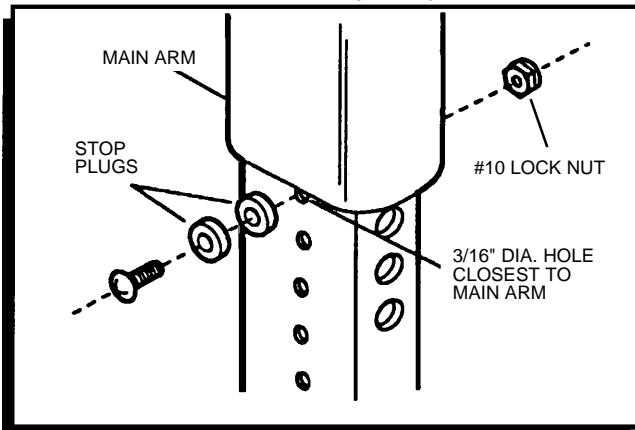
1.7 STOP PLUG

The stop plug is a mechanical stop that supports the main arm when opening and closing the awning. It controls the clearance between the top casting of the torsion to the extension of the top mounting bracket. This clearance should be 1/4 inch to 1 inch. To adjust the clearance, raise or lower the stop plug as needed. On the 9000 and 9500 Series awning the clearance should be kept to a minimum for best operation.

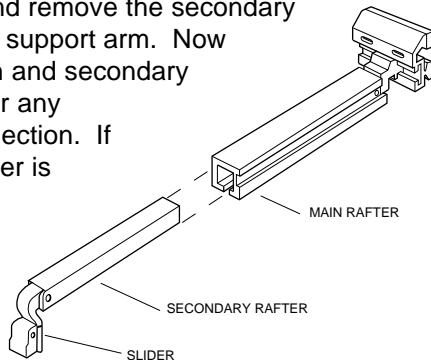
1.8 RAFTERS

The rafters telescope from the top mounting brackets to the main support arms to provide tension on the fabric in the full open position. If the rafters are bent or twisted, this will hinder the operation of the awning. Open the awning and remove the secondary rafter from the main support arm. Now sight down the main and secondary rafters and check for any bends, twists or deflection. If one or the other rafter is not true it should be replaced.

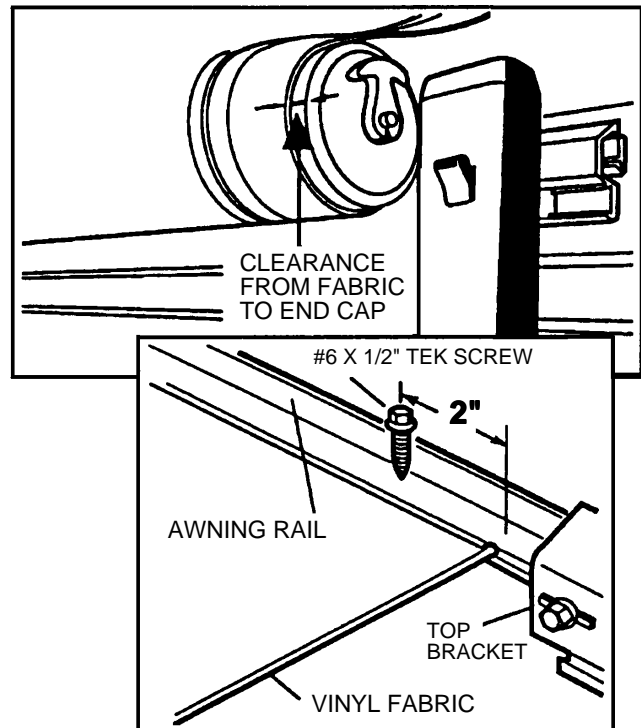
2.1 POSITION

For the awning to operate properly the fabric must be positioned properly in the awning rail and on the roller tube. Open the awning and check the position of the fabric between the top mounting brackets. If the fabric is not centered, remove the tek screws, center it, and replace the screws.

When the fabric is properly positioned, next check the position of the fabric on the roller tube. The clearance from the end cap of the torsion assembly to the edge of the fabric must be the same on each end. If it is not, adjust the fabric on the tube as necessary. On the Elite 9000 and 9500 awning the fabric is held in place to the weatherguard with 1/8" pop rivets. Check the position of the fabric at each end of the weatherguard. If the fabric has shifted, remove the pop rivets, center the fabric and re-rivet.

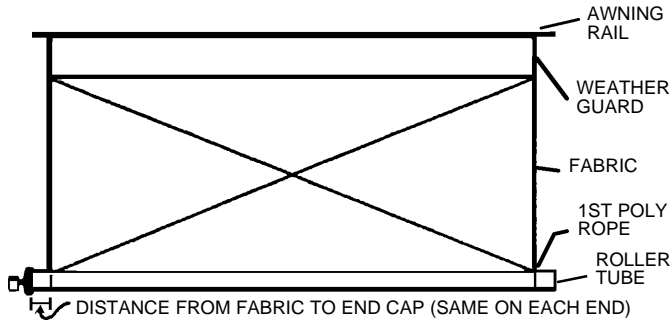
2.2 SQUARE

If the fabric on the awning is out of square, it could cause the fabric to telescope in one direction when rolling up, or to not hang properly in the open position.

To check fabric for square, measure from the top right hand corner of the fabric (not the weatherguard) to the bottom left hand corner at the poly rope. Now measure from the top left hand corner to the bottom right hand corner as shown below.

In this check, the difference of the two dimensions should be no more than one inch. If it is more, the fabric is out of square, and replacement would be necessary.

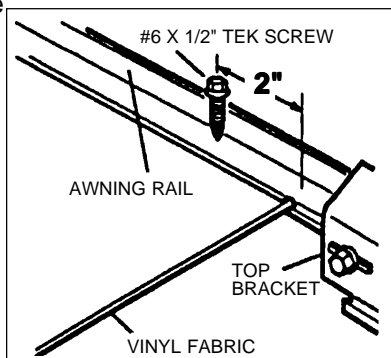
2.3 WEATHERGUARD

The weatherguard is the last 15 inches of the awning that encloses the fabric in the rolled up position. It protects the striped fabric from the environment and elements. The weatherguard is a heavy 17 oz. vinyl fabric.

When the vinyl weatherguard or fabric has excessive wrinkles, it will be necessary to stretch the weatherguard or fabric. Open the awning and allow the fabric to warm up. Remove one Tek screw, grasp the weatherguard, stretch it, and resecure the screw. Repeat this procedure for the other end, making sure to stretch each side an equal distance, keeping the fabric centered between the top mounting brackets. Close and reopen the awning three times. If wrinkles are still present, repeat the above stretching procedure. This may have to be done 4 or 5 times before all wrinkles disappear.

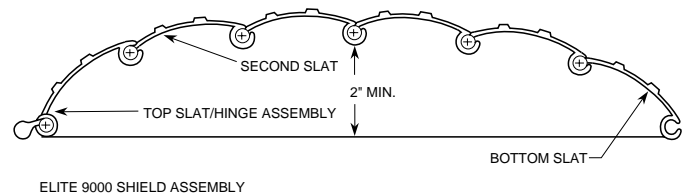
2.5 ALUMINUM GUARD

When the awning is fully extended, the aluminum guard should have an arch of at least 2 inches. The arch helps water to run off rather than between the sections of the guard.

To check the aluminum guard for proper arch, open the awning to full extension, making sure the fabric is taut. Hold a flat edge to the bottom of the guard and measure from the flat edge to the inside of the arch at its highest point. If the measurement is less than 2 inches, the guard should be replaced.

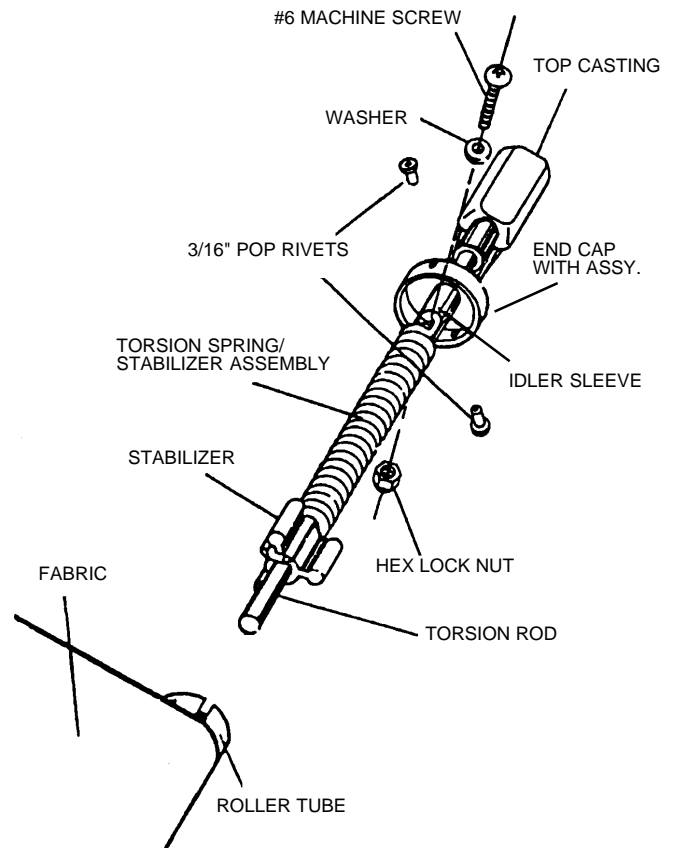
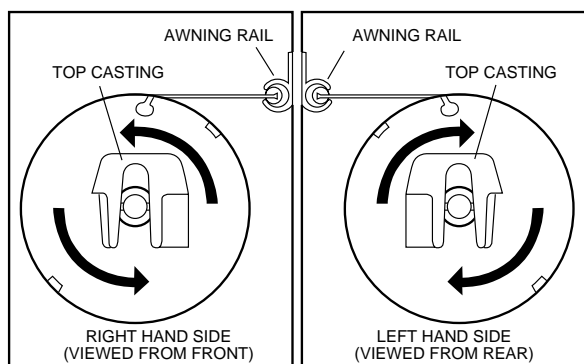
2.8 TORSION

When difficulties are experienced in rolling the awning up, the tension on the torsion should be checked. In

most cases adding a few turns of torque to each end will correct the problem. If all tension has been lost, refer to the following chart and apply the specified number of turns as indicated. This must be done with the awning extended two feet away from the coach.

When winding the torsion, be sure to wind in the proper direction.

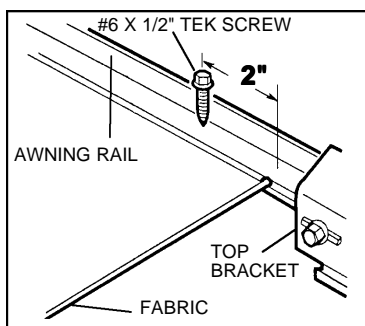
2.12 TEK SCREWS

The Tek screws are the two screws installed through the awning rail of the coach. They keep the aluminum guard from shifting in the awning rail. On vinyl and some acrylic awnings (see Sec. 2.5) they keep the fabric from shrinking with age. If one Tek screw is missing, the fabric will pull toward the remaining Tek screw causing the fabric to wrinkle.

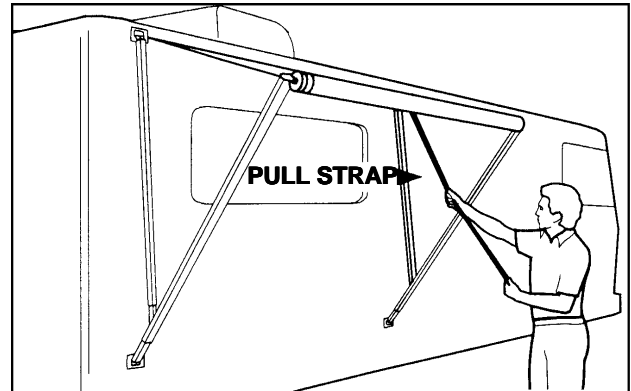
3.2 CLOSING

On the 9000 and 9500 Series, when rolling up the awning, the roller tube assembly should not be slowed down before reaching the aluminum guard. This could cause the roller tube to stall at the guard.

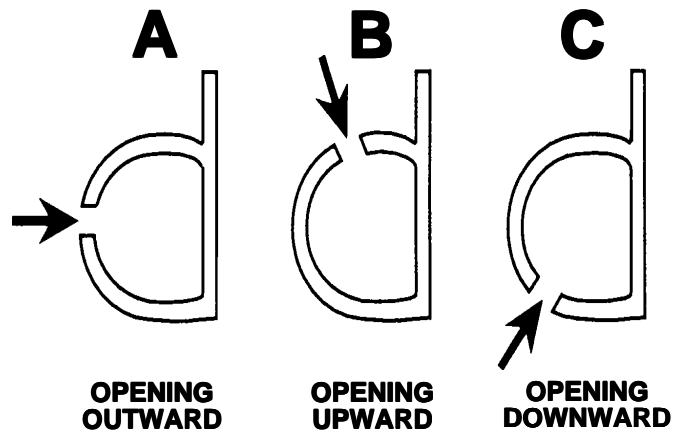
4.3 TYPE

There are three types of awning rail used in the RV industry. Of these, type A and B (see below) are acceptable for use on the 9000 Series awning that utilizes a hinge slat (see Sec.2.5) . Type C should never be used on the 9000 Series that utilizes a hinge slat (see Sec. 2.5) as it could cause a binding problem on the aluminum guard assembly, but it is acceptable on the vinyl awnings.
