This program will address the most common system problems associated with the A&E Patio Awnings supplied by The Dometic Corporation. Our intent is to provide you with a guideline of checks to make, should you encounter one of the following symptoms.

SECTION 1 HARDWARE COMPONENTS

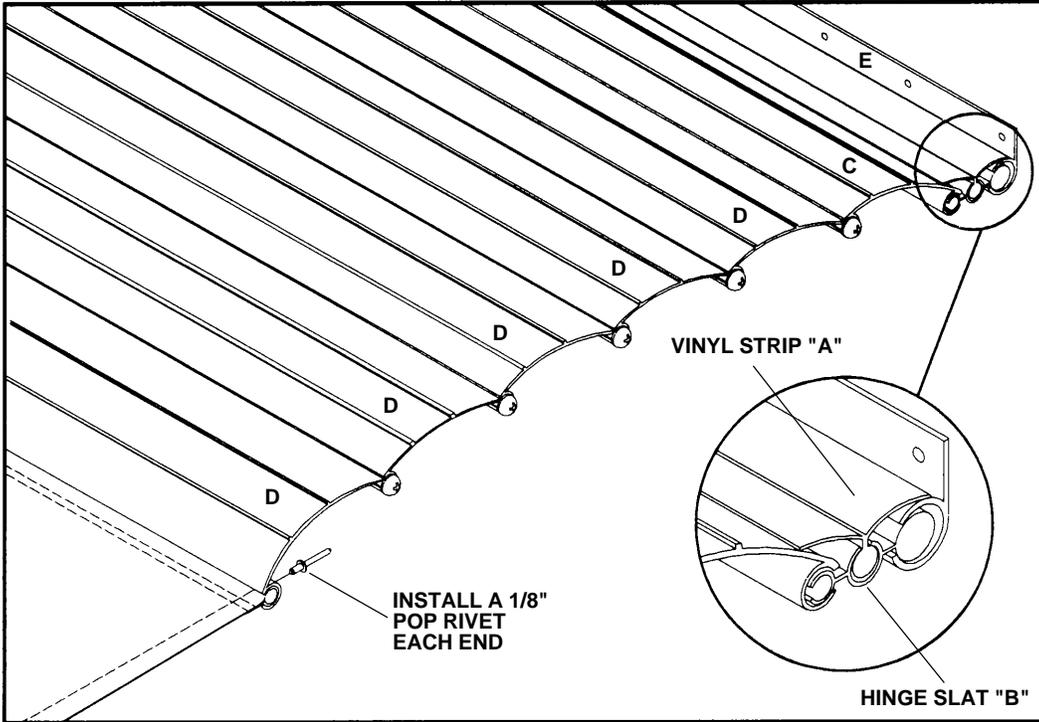
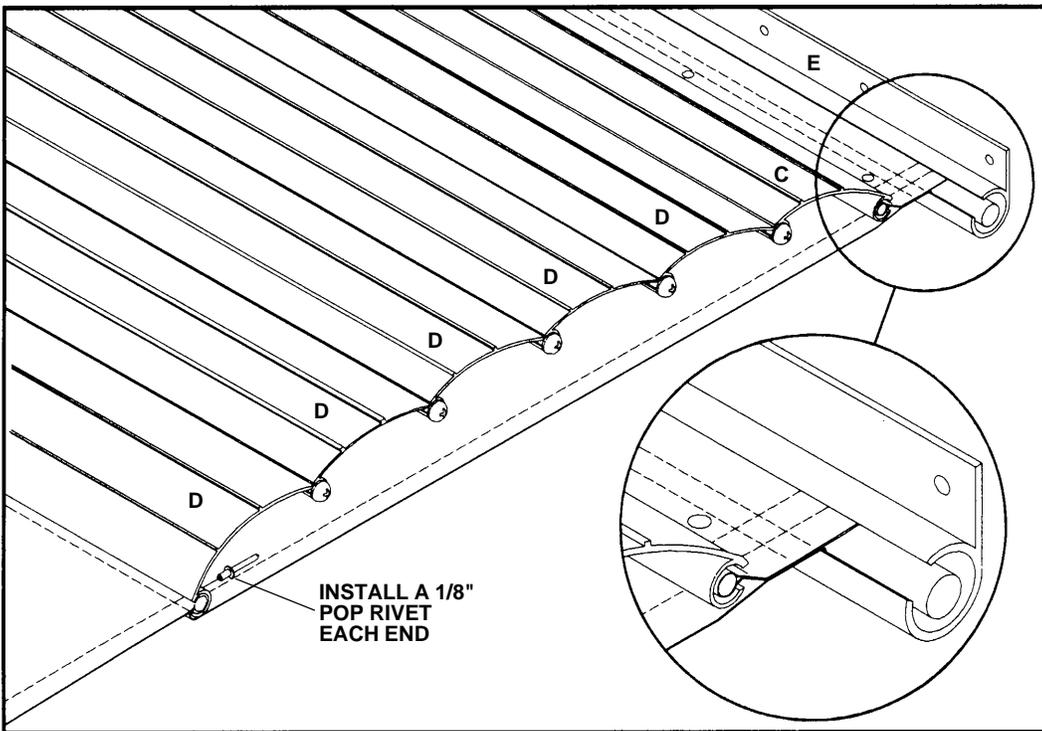
9000 WITH HINGE SLAT

If the roller tube is bent, it will bounce up and down when opening and closing the awning. On the 9000 Series this can cause the aluminum guard to leak, because the guard assembly may not be tight.
