This program will address the most common system problems associated with the A&E Patio Awnings supplied by The Dometic Corporation. Our intent is to provide you with a guideline of checks to make, should you encounter one of the following symptoms.

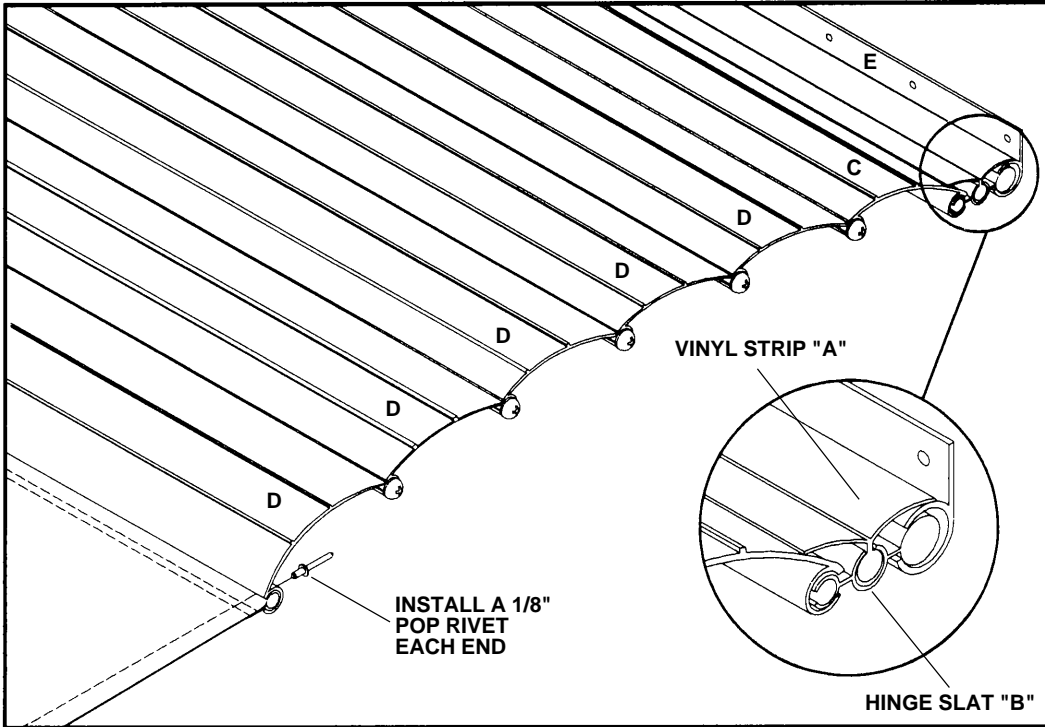
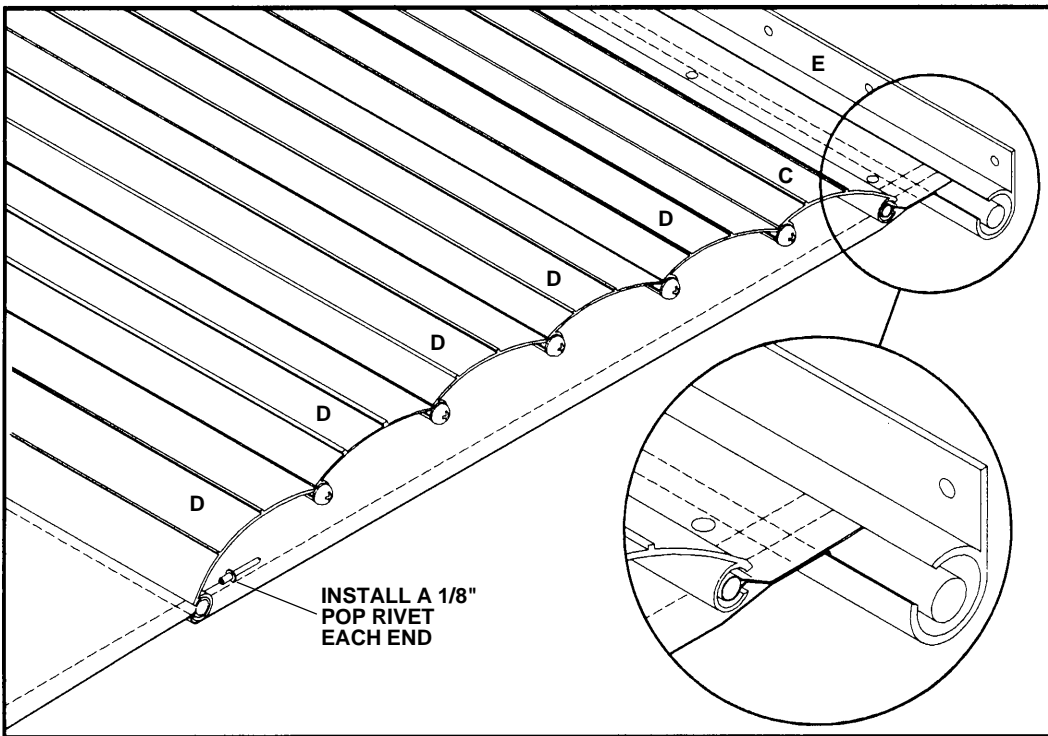
9000 WITH HINGE SLAT

- A - VINYL STRIP**
- B - HINGE SLAT**
- C - TOP SLAT**
- D - MAIN SLAT**
- E - AWNING RAIL**

TOP SLAT "C"
VIEW RH END

MAIN SLAT "D"
VIEW RH END

HINGE SLAT "B"

If the roller tube is bent, it will bounce up and down when opening and closing the awning. On the 9000 Series this can cause the aluminum guard to leak, because the guard assembly may not be tight.

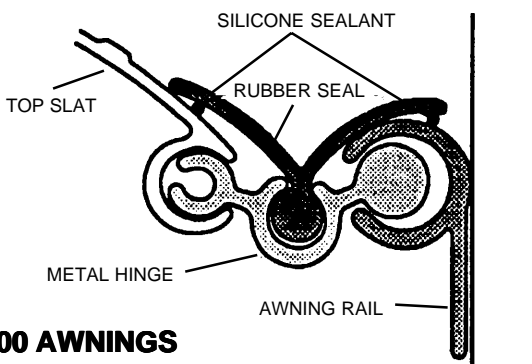
2.8 TORSION

**9000 AWNINGS
WITH HINGE
SLAT**
