This program will address the most common system problems associated with the A&E Patio Awnings supplied by The Dometic Corporation. Our intent is to provide you with a guideline of checks to make, should you encounter one of the following symptoms.

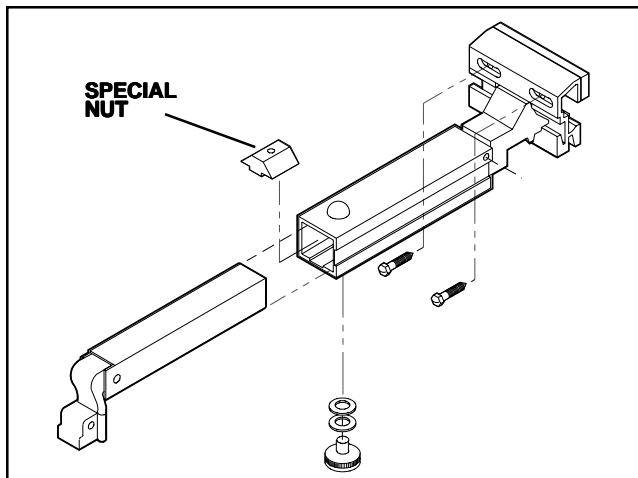
On some arm assemblies the nutsert has been replaced with a **SPECIAL NUT**. If the knob will not tighten, first separate the rafter assembly. Turn the knob to determine if the special nut is stripped. If so, replace the special nut. If you cannot turn the knob, it will be necessary to replace both the special nut and the back adjustment knob.

NOTE: The special nut could be a large hex nut as well as the one shown.

The **nutsert** is simply a threaded fastening device used to tighten down the black adjustment knob. If the knob will not tighten, first remove the secondary rafter assembly from the hardware. Turn the knob to determine if the nutsert is stripped or spinning. If so, replace the nutsert. If you cannot turn the knob it will be necessary to replace both the nutsert and the black adjustment knob.

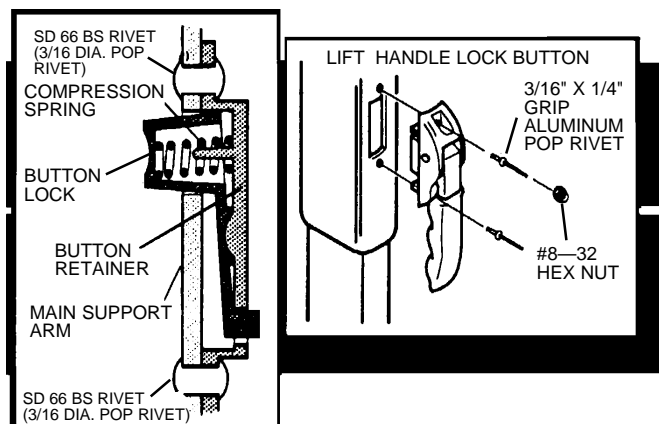
1.3 PUSH BUTTON ASSEMBLY

The push button assembly locks the main support arm to the adjustable arm assembly and controls the height of the awning in the open position. To check it, open the awning to full extension. Look inside the main support arm, and activate the push button to see if the locking pin is moving in and out of the hole in the adjustable arm assembly. If the locking pin does not move, or has been

broken off, the push button assembly must be replaced. At times the lock pin of the push button assembly can break off and jam between the push button housing and the adjustable arm assembly, making it difficult to extend the main support arm.

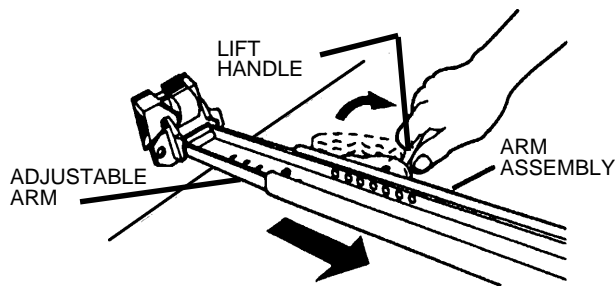
1.4 ADJUSTABLE ARM ASSEMBLY

The adjustable arm assembly allows for telescoping height adjustment of the main support arm, and it connects to the bottom mounting bracket to support the weight of the awning. If the main support arm cannot be extended freely, the adjustable arm assembly should be checked. Remove the adjustable arm assembly and check for nicks, burrs, bends or twists. If any deflection is noted, the adjustable arm assembly must be replaced. For ease of operation apply GO-EASY, a special lubricant.

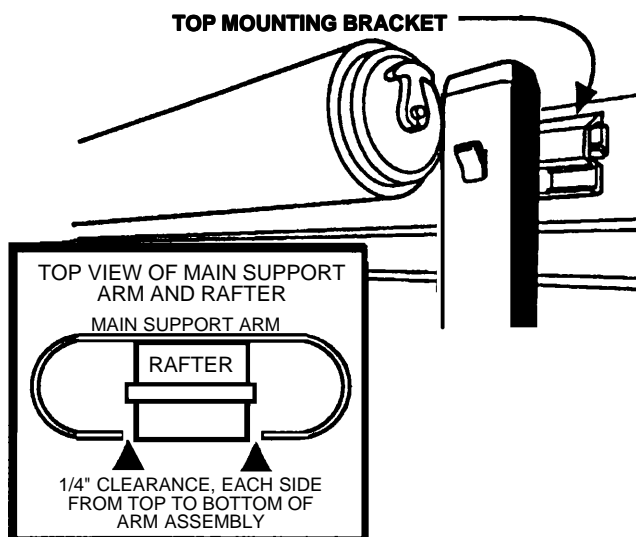
1.5 TOP MOUNTING BRACKETS

The top mounting bracket supports the main rafter assembly to hold the awning in the open extended position, and allows the rafter to pivot into the "C" channel of the main support arm. Each top mounting bracket should be mounted directly over the awning rail so the screws go through the "C" portion of the rail.

On the Series 9000 awning the top mounting bracket can be mounted lower when possible. If the top mounting bracket is mounted above center of the awning rail, the aluminum guard may not cover the fabric completely in the closed position. If this is the case, relocate the top mounting bracket accordingly.

The top mounting brackets have slotted holes for the mounting screws, allowing them to be adjusted side to side. To adjust the brackets, close the awning and sight down the main support arm and the main rafter. The clearance on each side of the rafter should be approximately 1/4 inch. If clearance is not appropriate, adjust the top mounting bracket(s) as necessary.

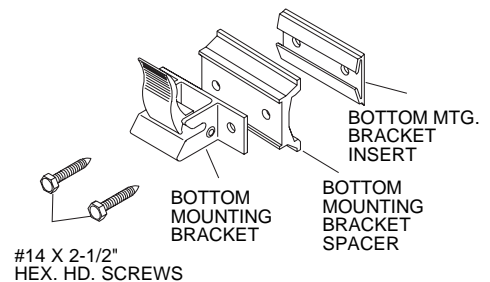
1.6 BOTTOM MOUNTING BRACKETS

The bottom mounting brackets are screwed to the floor line of the unit, and they support the weight of the awning. They also provide a quick release to set up the awning in the patio

position. If a bottom mounting bracket settles, sags, or becomes loose it can reduce the clearance between the top casting of the torsion and the extension of the top mounting bracket, making operation difficult. Check the bottom mounting bracket for looseness or settling, and tighten or reposition it accordingly for proper operation.

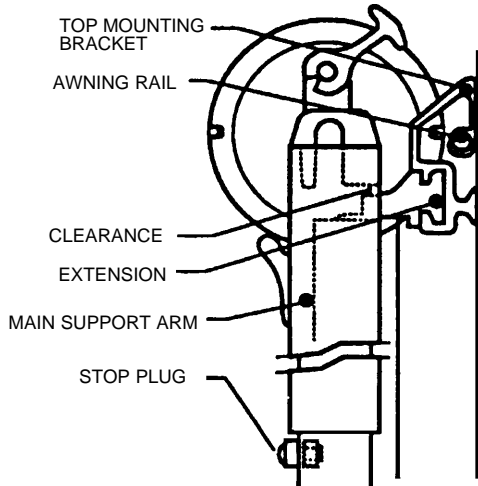
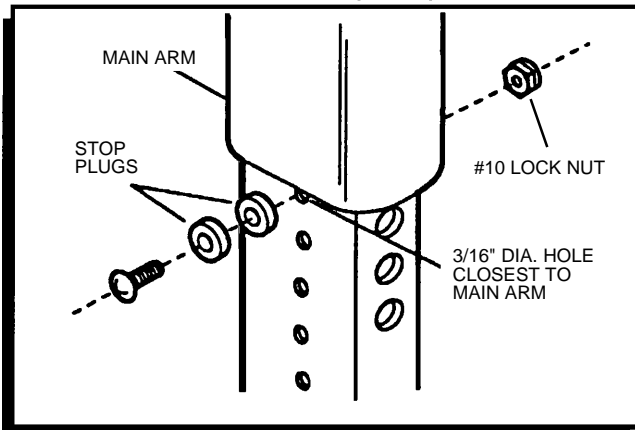
1.7 STOP PLUG

The stop plug is a mechanical stop that supports the main arm when opening and closing the awning. It controls the clearance between the top casting of the torsion to the extension of the top mounting bracket. This clearance should be 1/4 inch to 1 inch. To adjust the clearance, raise or lower the stop plug as needed. On the 9000 and 9500 Series awning the clearance should be kept to a minimum for best operation.

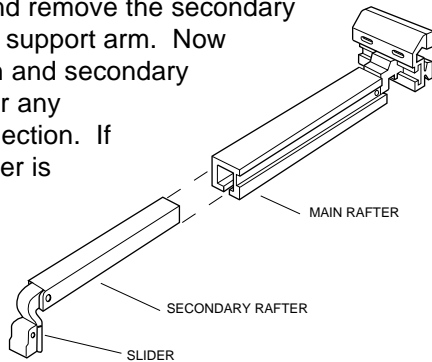
1.8 RAFTERS

The rafters telescope from the top mounting brackets to the main support arms to provide tension on the fabric in the full open position. If the rafters are bent or twisted, this will hinder the operation of the awning. Open the awning and remove the secondary rafter from the main support arm. Now sight down the main and secondary rafters and check for any bends, twists or deflection. If one or the other rafter is not true it should be replaced.

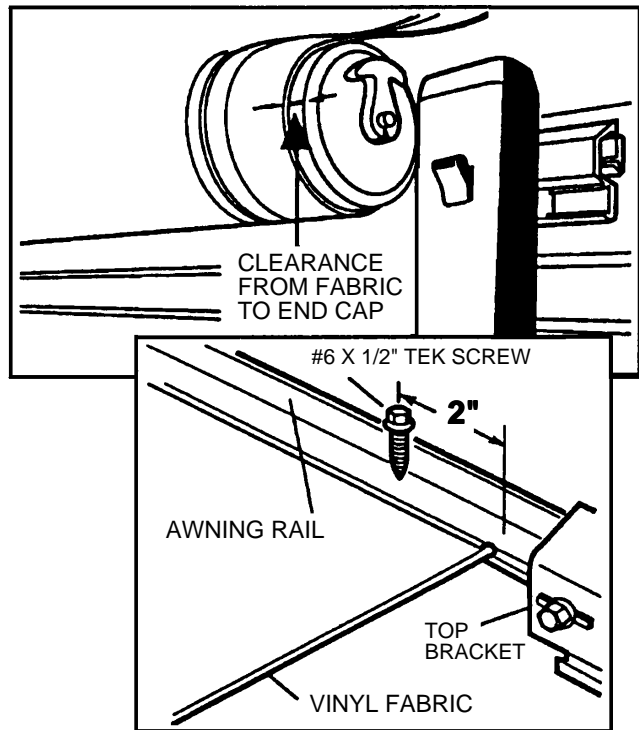
2.1 POSITION

For the awning to operate properly the fabric must be positioned properly in the awning rail and on the roller tube. Open the awning and check the position of the fabric between the top mounting brackets. If the fabric is not centered, remove the tek screws, center it, and replace the screws.

When the fabric is properly positioned, next check the position of the fabric on the roller tube. The clearance from the end cap of the torsion assembly to the edge of the fabric must be the same on each end. If it is not, adjust the fabric on the tube as necessary. On the Elite 9000 and 9500 awning the fabric is held in place to the weatherguard with 1/8" pop rivets. Check the position of the fabric at each end of the weatherguard. If the fabric has shifted, remove the pop rivets, center the fabric and re-rivet.

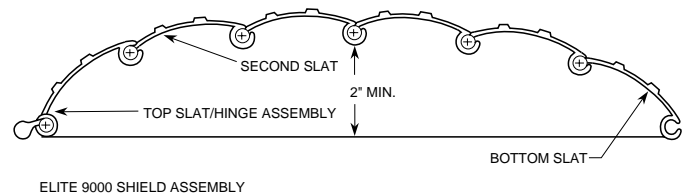
When the awning is fully extended, the aluminum guard should have an arch of at least 2 inches. The arch helps water to run off rather than between the sections of the guard.

To check the aluminum guard for proper arch, open the awning to full extension, making sure the fabric is taut. Hold a flat edge to the bottom of the guard and measure from the flat edge to the inside of the arch at its highest point. If the measurement is less than 2 inches, the guard should be replaced.

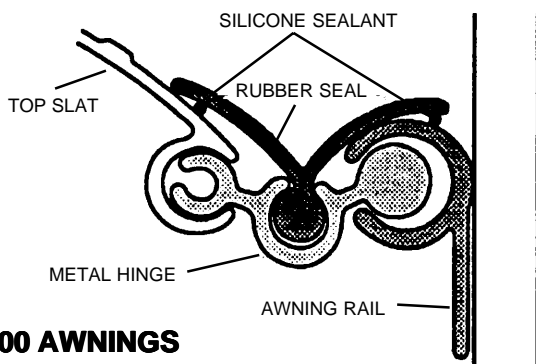
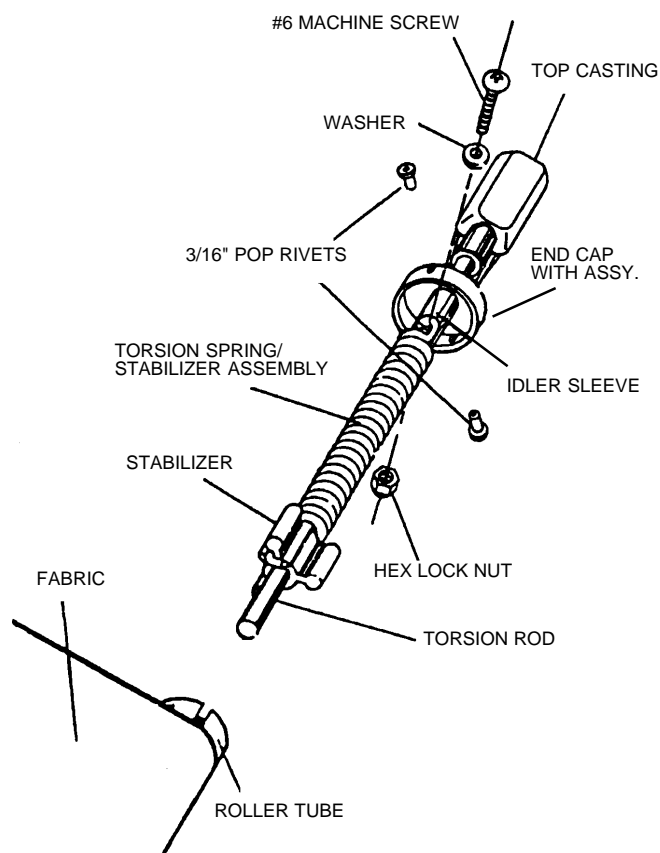
**9000 AWNINGS
WITH HINGE
SLAT**

The torsion assembly has a wound coil spring which

provides tension on the roller tube to roll the awning up into the travel position.

The right hand torsion end cap contains a cam assembly which prevents the awning from billowing or unrolling during travel. It also allows one-person set-up of the awning by preventing rollback.

When difficulties are experienced in rolling the awning up, the tension on the torsion should be checked. In

most cases adding a few turns of torque to each end will correct the problem. If all tension has been lost, refer to the following chart and apply the specified number of turns as indicated. This must be done with the awning extended two feet away from the coach.

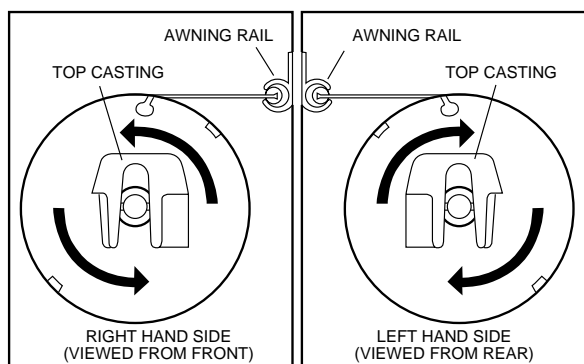
See Spring Identification Chart for No. of Turns

When winding the torsion, be sure to wind in the proper direction.

SEVERE INJURIES CAN RESULT FROM THE SPINNING TOP CASTING. USE VISE GRIPS® (NEVER BARE HANDS) TO GRASP TOP CASTING WHILE LOADING TORSION.

Note: Rewinding must be done with the Awning Fabric extended two feet away from the coach.

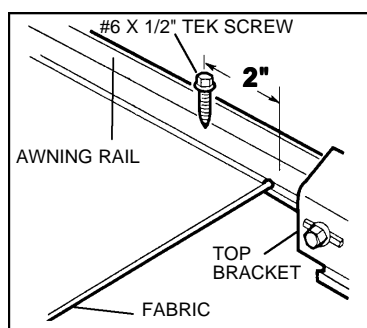
2.12 TEK SCREWS

The Tek screws are the two screws installed through the awning rail of the coach. They keep the aluminum guard from shifting in the awning rail. On vinyl and some acrylic awnings (see Sec. 2.5) they keep the fabric from shrinking with age. If one Tek screw is missing, the fabric will pull toward the remaining Tek screw causing the fabric to wrinkle.

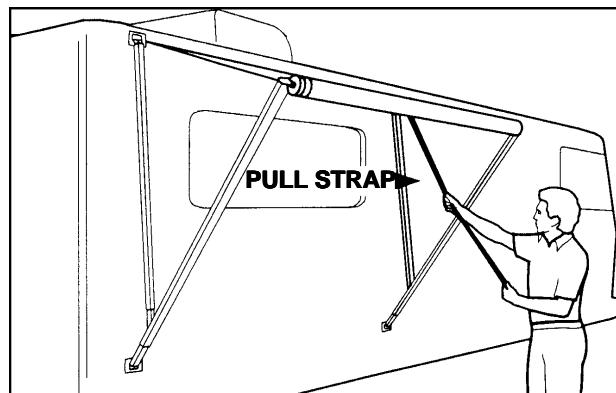
3.2 CLOSING

On the 9000 and 9500 Series, when rolling up the awning, the roller tube assembly should not be slowed down before reaching the aluminum guard. This could cause the roller tube to stall at the guard.
